# Mobile Intel® Celeron® Processor on .13 Micron Process in Micro-FCPGA Package

Specification Update

*June 2004*

Document Number: 251309-021

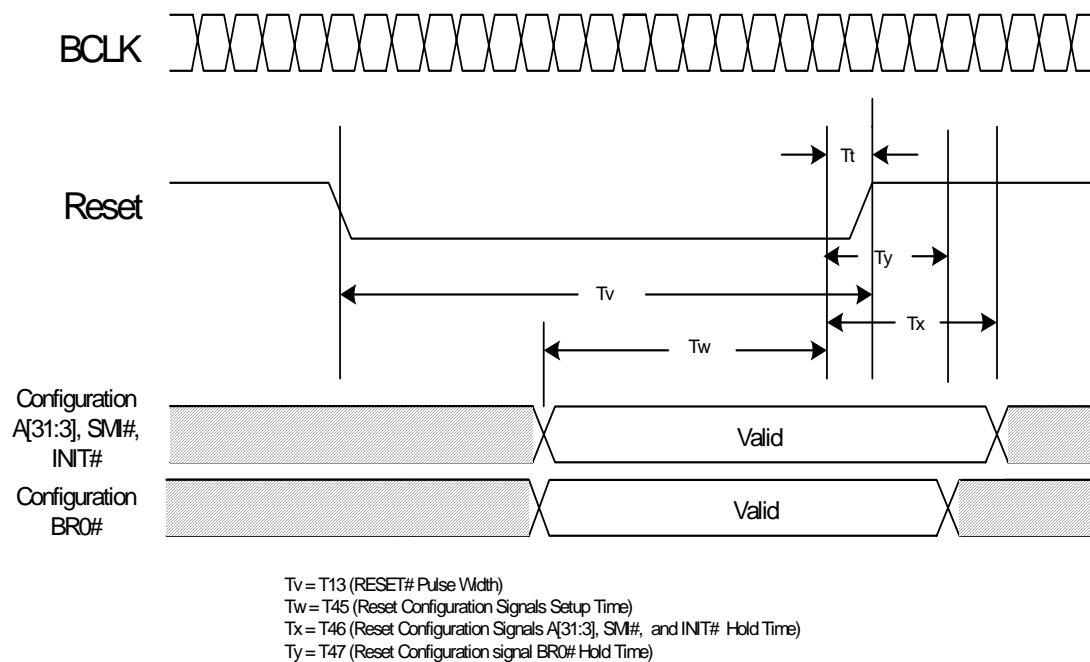
**Figure 2. System Bus Reset and Configuration Timings**

The BR0# maximum hold time has changed to 2 BCLKs. This change will be shown in the “System Bus AC Specifications (Reset Conditions)” table and “System Bus Reset and Configuration Timings” figure of the *Mobile Intel® Celeron® Processor on .13 Micron Process in Micro-FCPGA Package Datasheet*. This change will be incorporated in the next revision of the datasheet.

The following figure will be modified to reflect this change
